Assessment - Newtown-Hoffman Creeks Watershed Project - Floodwater
Retarding Dam Site 18

DEC I.D. 61D-4285

PHASE I INSPECTION REPORT
NATIONAL DAM SAFETY PROGRAM
NEWTOWN-HOFFMAN CREEKS WATERSHED PROJECT -
FLOODWATER RETARDING DAM SITE 18
N.Y. 700
DEC I.D. NO. 61D-4285
CHEMUNG RIVER BASIN
CHEMUNG COUNTY, NEW YORK

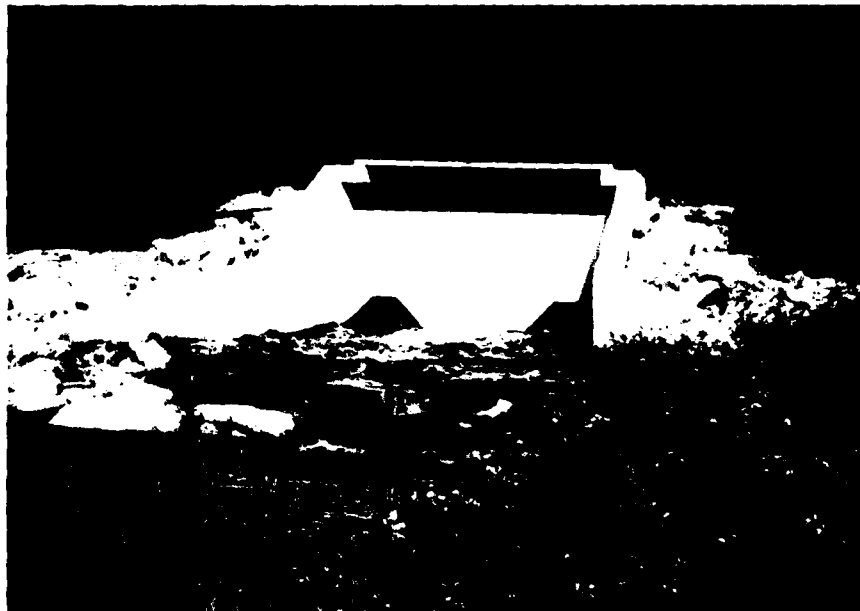
PHOTOGRAPH NO. 7
Primary Spillway Impact Basin

- a. Concrete Surfaces The concrete riser and outlet structure
appear to be in good condition.
- b. Structural Cracking The outlet structure had some cracking
on the baffle slab.
- c. Movement - Horizontal & Vertical Alignment (Settlement)
None observed.
- d. Junctions with Abutments or Embankments
No problems observed.
- e. Drains - Foundation, Joint, Face
No problems observed.
- f. Water Passages, Conduits, Sluices
N/A
- g. Seepage or Leakage None observed.
